TECHNICAL PUBLICATION # 79-2

June 1979

IMPROVEMENT OF THE CANAL-AQUIFER
FLOW REGIME IN THE C-1N BASIN

Resource Planning Department
South Florida Water Management District
West Palm Beach, Florida 33402

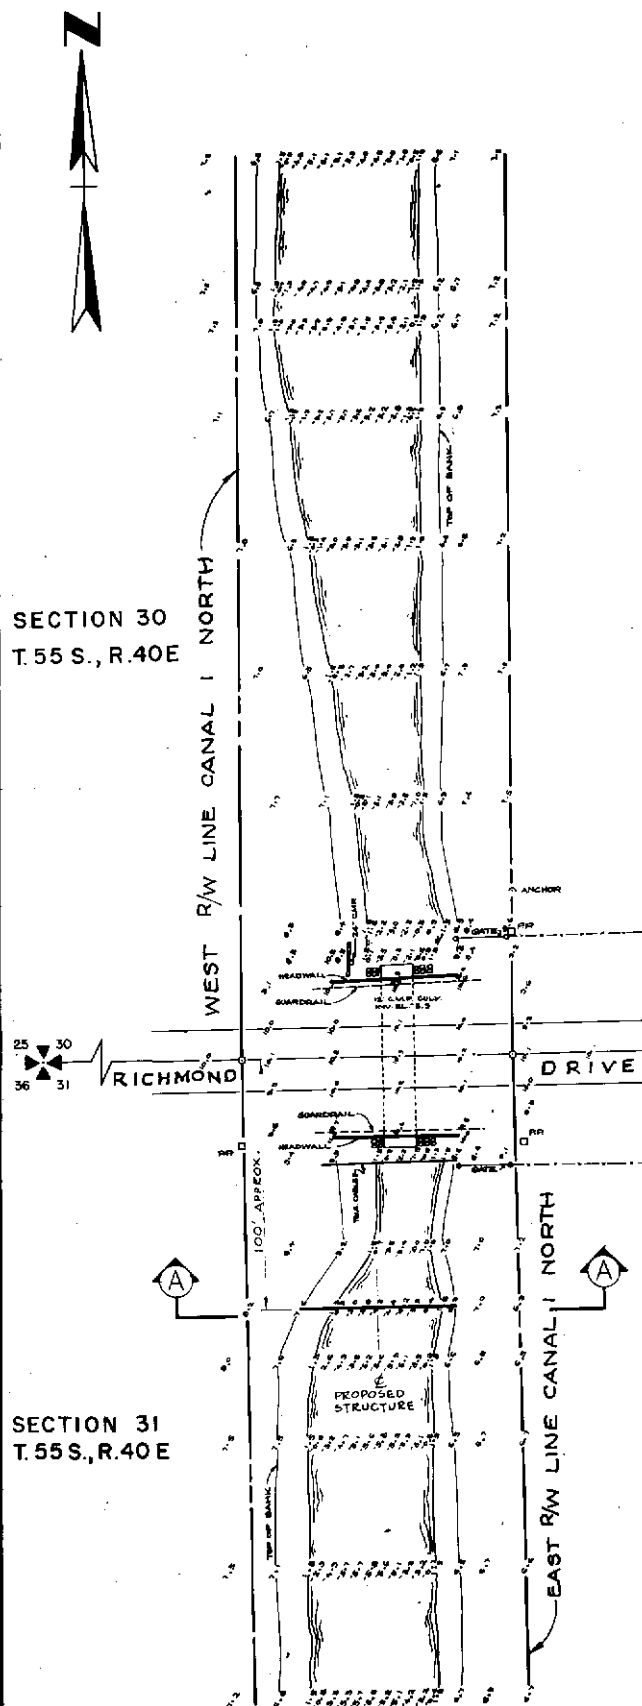
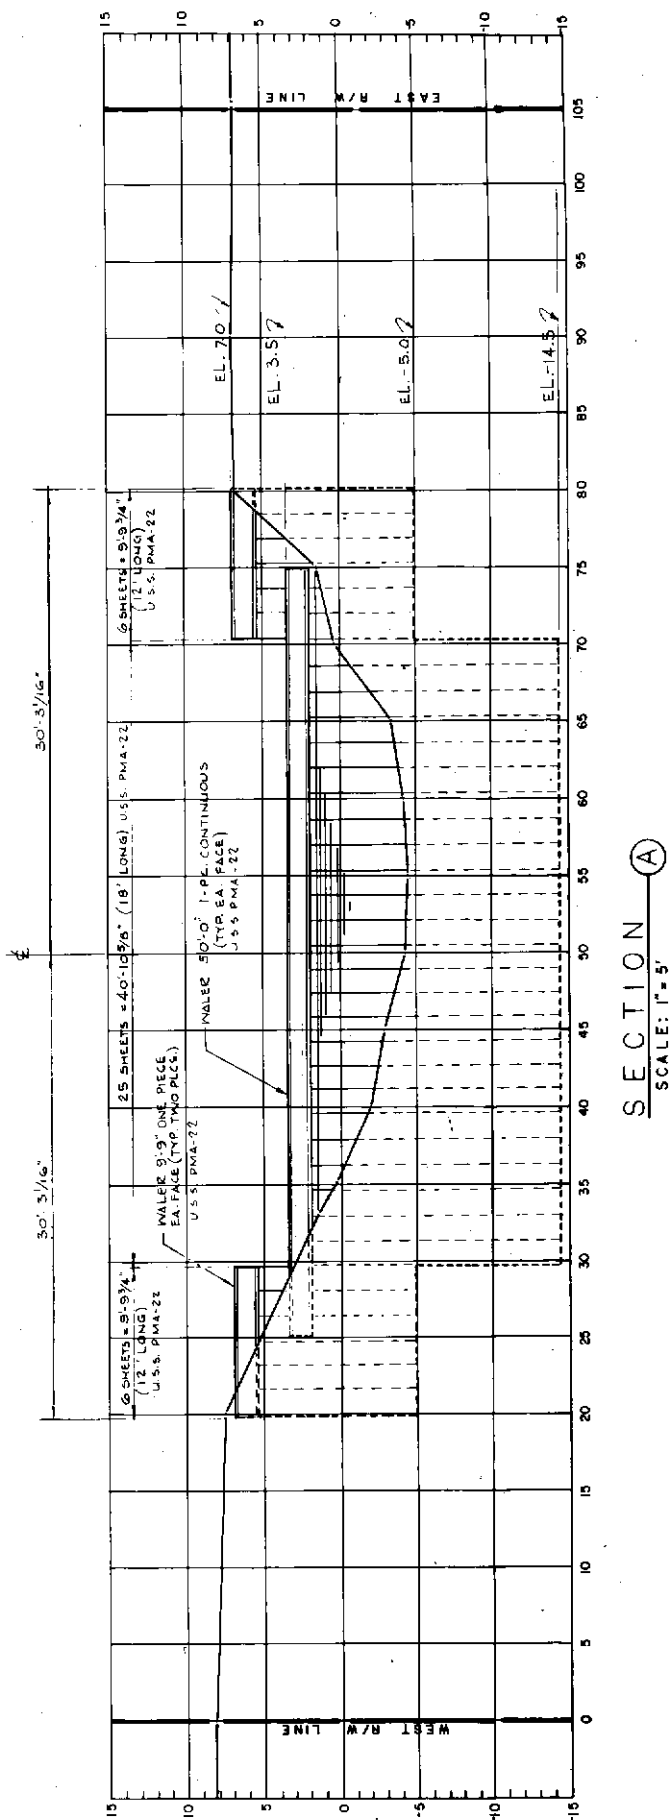
Figure 27

As a result of the investigation and conclusions above, and consideration of all feasible configurations for an additional channel structure, it is recommended that a steel sheet pile fixed-crest weir be constructed 100 feet south of the center line of Richmond Drive. The weir dimensions, elevations, and location are shown on Figure 27.

With a crest elevation of 3.5 feet msl, the weir will be submerged at the design water elevation of 6.3 feet msl; however, with a crest length of 40.89 feet, it will pass the design flow (230 cfs) with a downstream water elevation of 6.3 feet msl and an upstream water elevation of 6.45 feet msl.

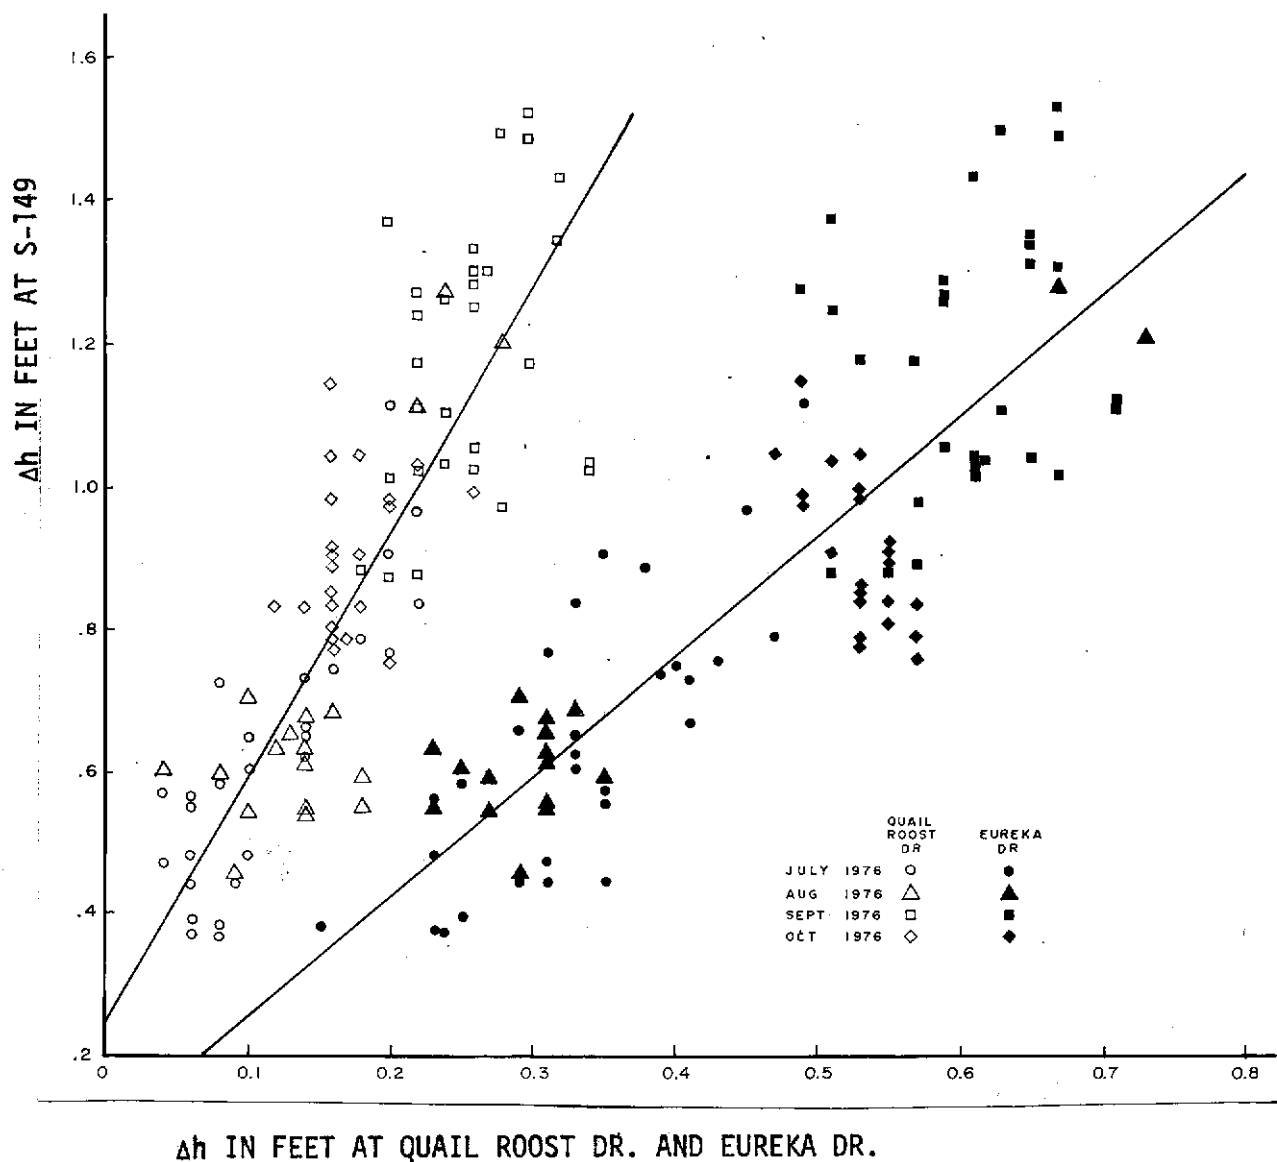
Regression analysis of Δh data during
data collection period No. 1.

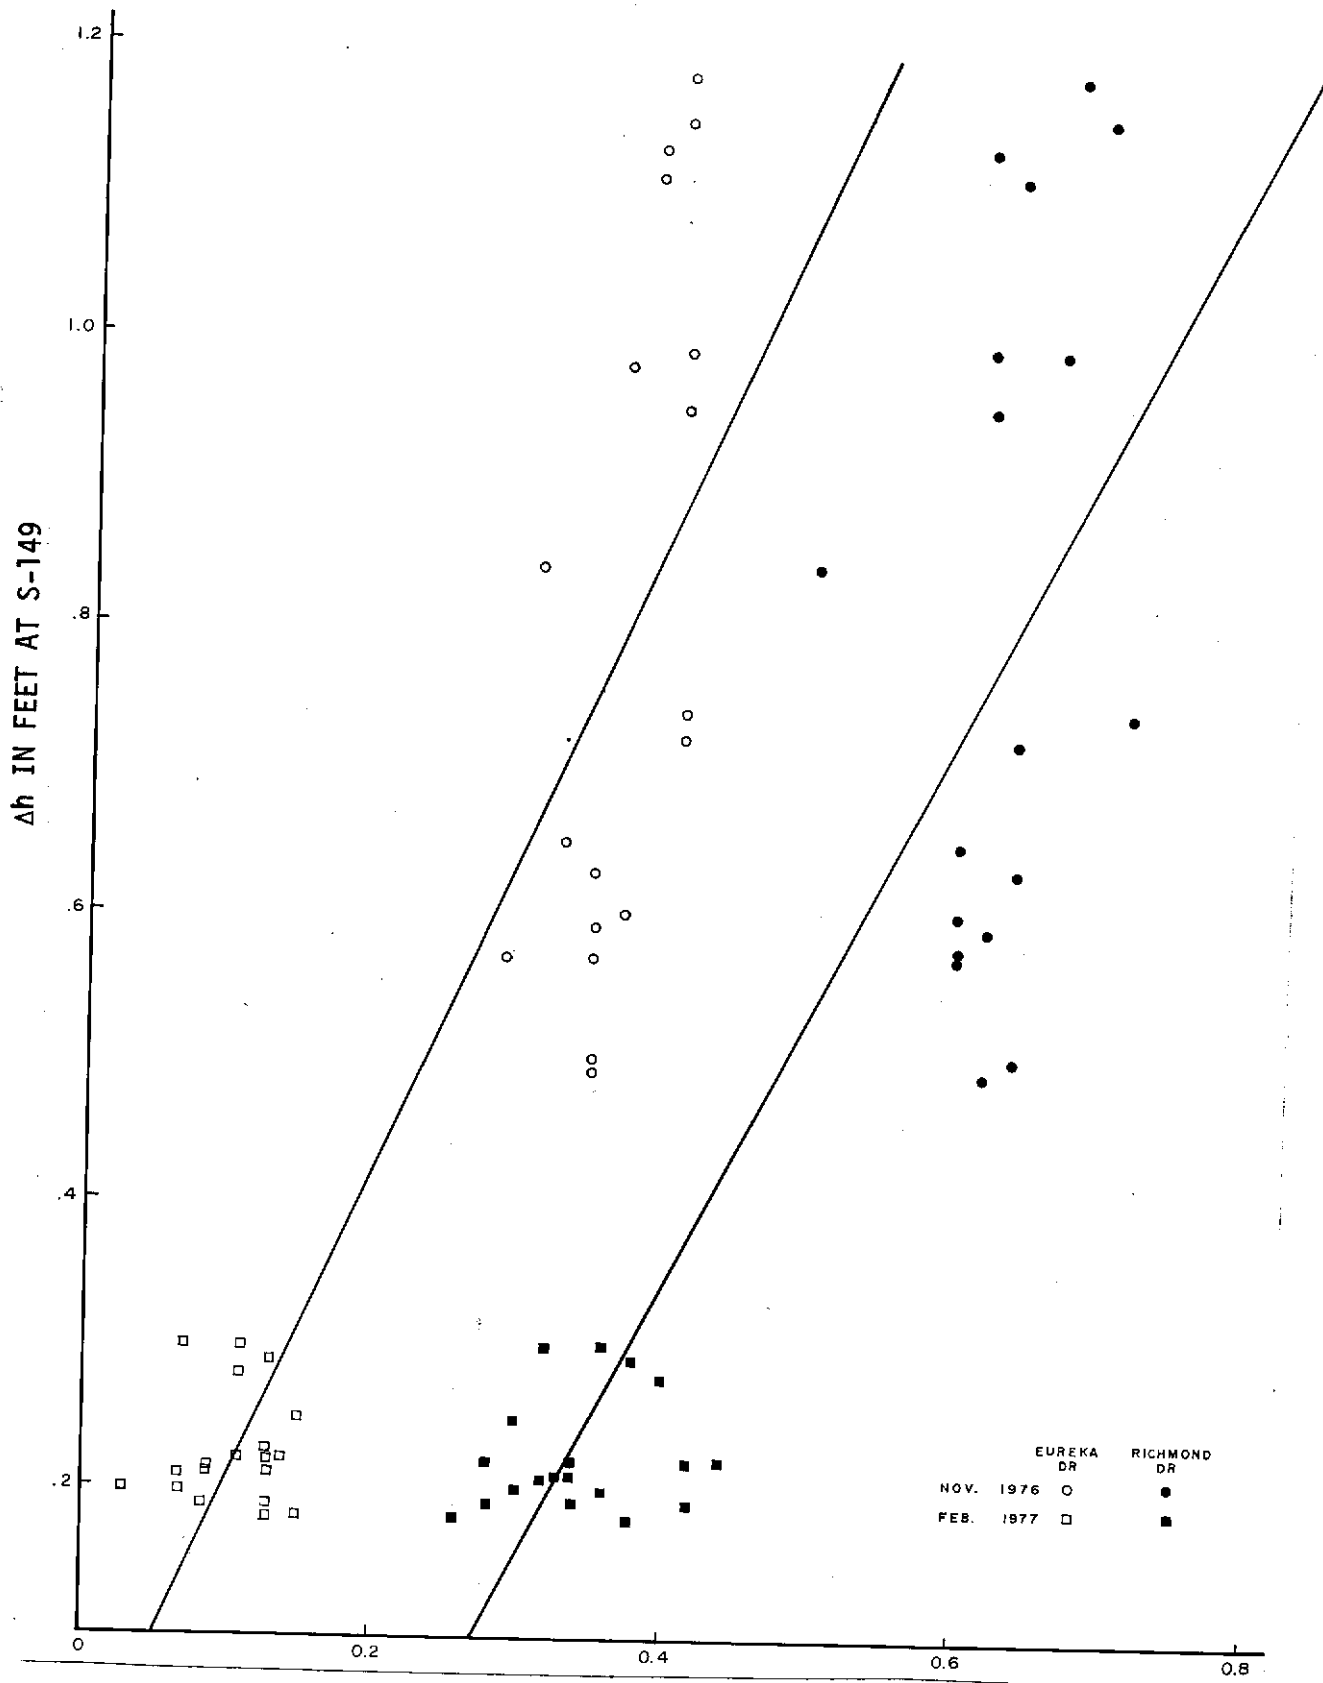
Regression analysis of Δh data during
data collection period No. 2.

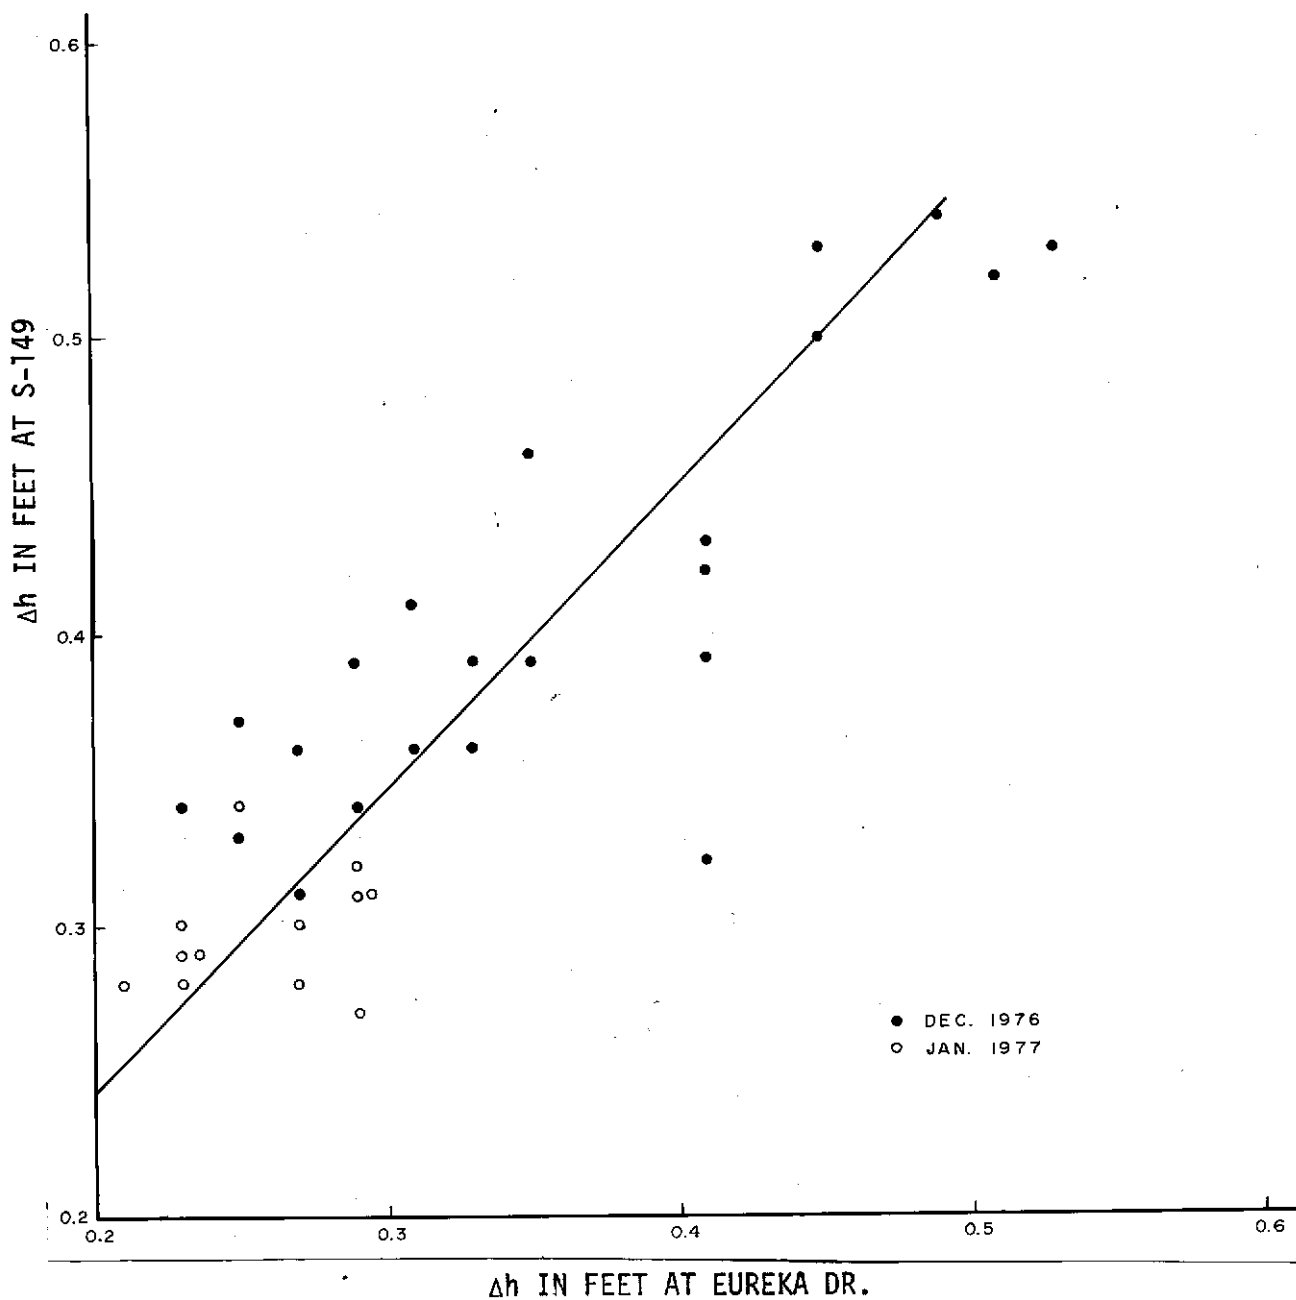
Regression analysis of Δh data during data collection period No. 3.
